U.S.S. IOWA EXPLOSION

Sandia National Laboratories' Final Technical Report

U.S.S. Iowa Explosion

FINAL REPORT

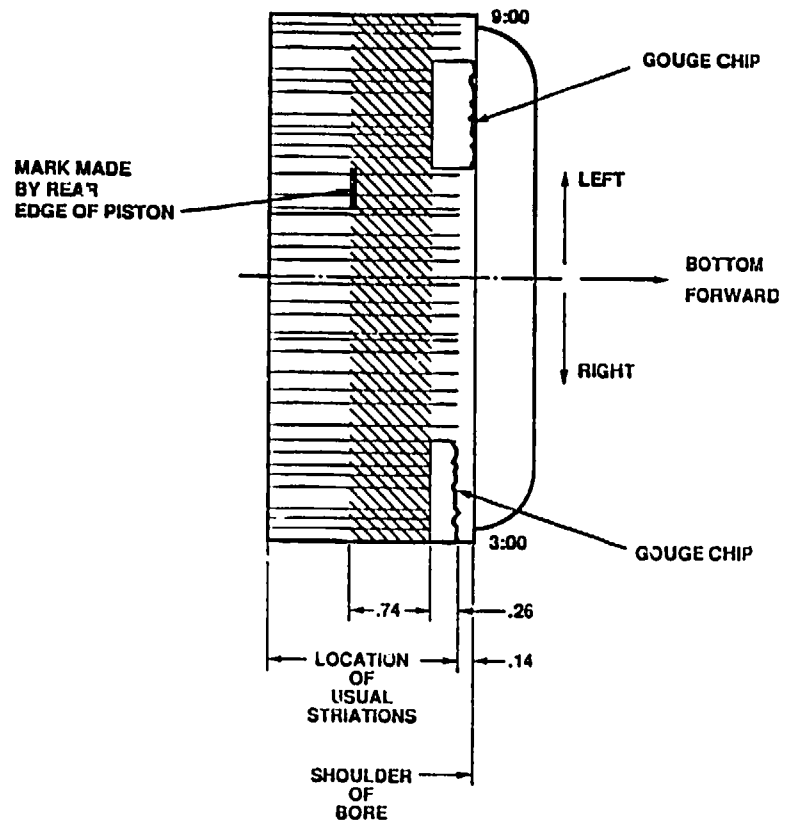
Examination of the front of the rammerhead shows that the right side of the buffer had received considerable damage caused by the impact with the bulkhead. On this side, the marks clearly show that the upper right side of the rammerhead impacted the small buffer located on the bulkhead. It is reasonable to associate the formation of the chip on the right with the impact of the rammerhead into the bulkhead, and the chip on the left with the initial blast force.

Figure 22. Developed surface of lower half of rammerhead bore.

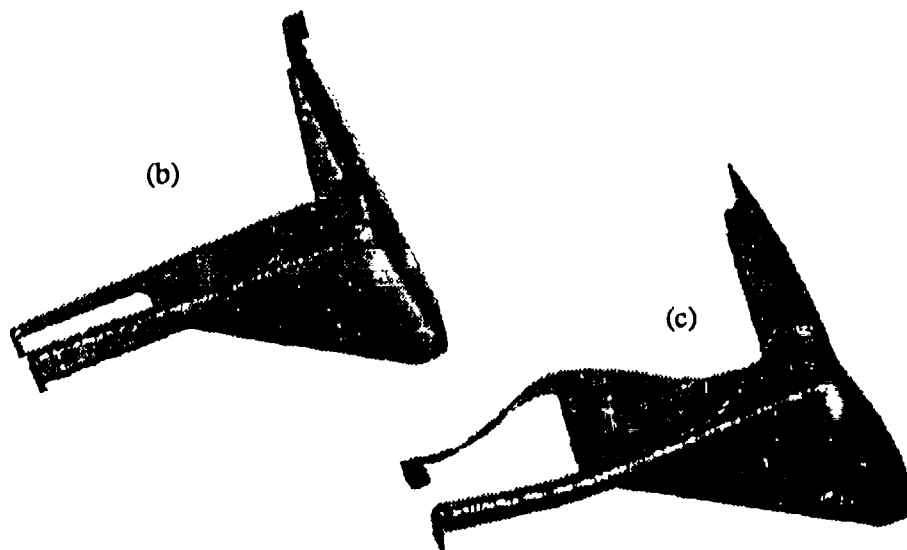
Figure 24. Photograph of:
(a) deformed rammerman's seat
(b) scale model of "as-designed" seat and
(c) scale model of "as-built and bent" seat

The top aft edge of the "as-built" seat also differs from the "as-designed" in that about one-half of the inboard side of the mounting flange had to be removed to clear piping mounted on the bulkhead. Figure 25 shows the location on the rear gun bulkhead where the seat mounting flange was secured by two 1/2 in. bolts. Directly outboard of the seat is a sheet metal mounting clip that secures two pipes in the corner of the gun room. Since this clip is undamaged, it can be concluded that the seat motion could not be directly outward since this would have crushed the clip and pipes. The rammerman foot rest also constrains the motion of the seat in the forward direction. The aft face of this foot rest on the USS IOWA was located 25 in. forward of the rear bulkhead. This permits about 5 1/4 in. of forward motion before the forward leg (which according to Figure 24a is virtually unbent) of the seat strikes the foot rest.
